# Manhole Inspection Summary

Manhole # S45G2\_017MH

Insp Date: **1/10/08 9:39 AM**

**Location** Address: **4420 Pennington Ave.**

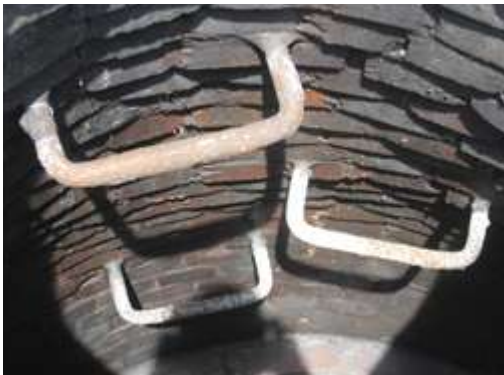
Steps

**Steps** Count: **3** Missing: **0** ☐ Corroded

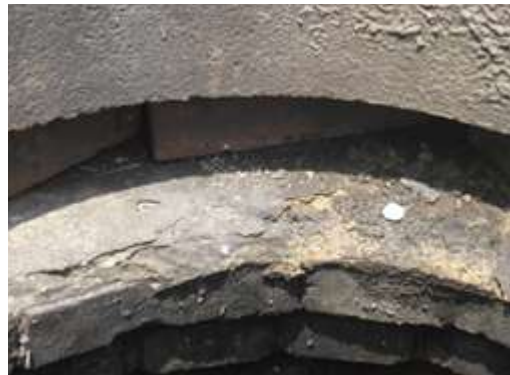
Defect 1

**Frame** Offset: **2** (in.) Condition: ☒ Sound ☐ Cracked ☐ Leaks

Frame offset

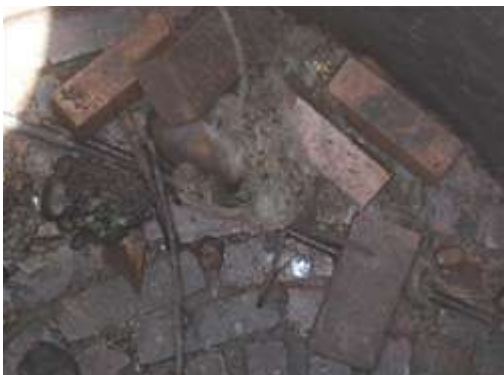
Defect 2

Condition: ☐ Sound ☐ Cracked ☐ Root Intrusion ☐ Deteriorated ☐ Leaks ☒ **Debris**

Debris on bench

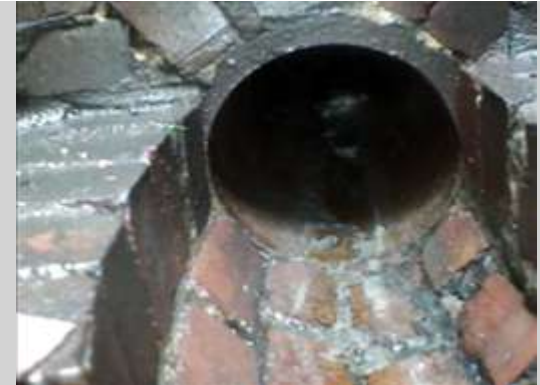
12 O'Clock Outflow

8 in. Circular Gravity Sewer  
Pipe Out @ 12 O'Clock

Pipe Height: **9.6** (in.) Rod and Bar (Angled)  
Pipe Material: **Clay** ☐ Pipe Lined  
Invert Depth: **7.71** (ft.) Flow Characteristics: **Slow**  
Deposits: ☒ None ☐ Mud ☐ Sludge ☐ Debris ☐ Grease  
Silt Depth: (in.) Deposits Extent:  
Infiltration: **None** Pipe Seal Cond: **Sound**

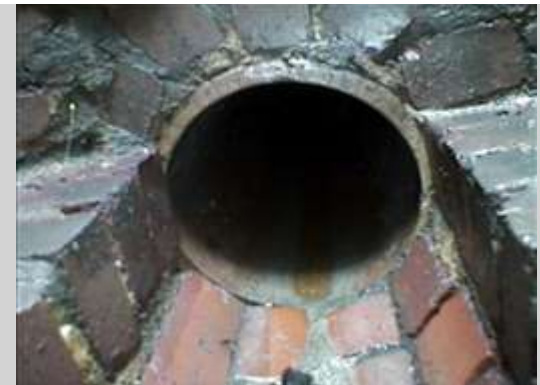
3 O'Clock Inflow

8 in. Circular Gravity Sewer  
Pipe In @ 3 O'Clock

Pipe Height: **8.4** (in.) Rod and Bar (Angled)  
Pipe Material: **Clay** ☐ Pipe Lined  
Invert Depth: **7.61** (ft.) Flow Characteristics: **Slow**  
Deposits: ☒ None ☐ Mud ☐ Sludge ☐ Debris ☐ Grease  
Silt Depth: (in.) Deposits Extent:  
Infiltration: **None** Pipe Seal Cond: **Sound**
